HEALTH & SAFETY
LABORATORY

Buncefield Oil Storage Depot

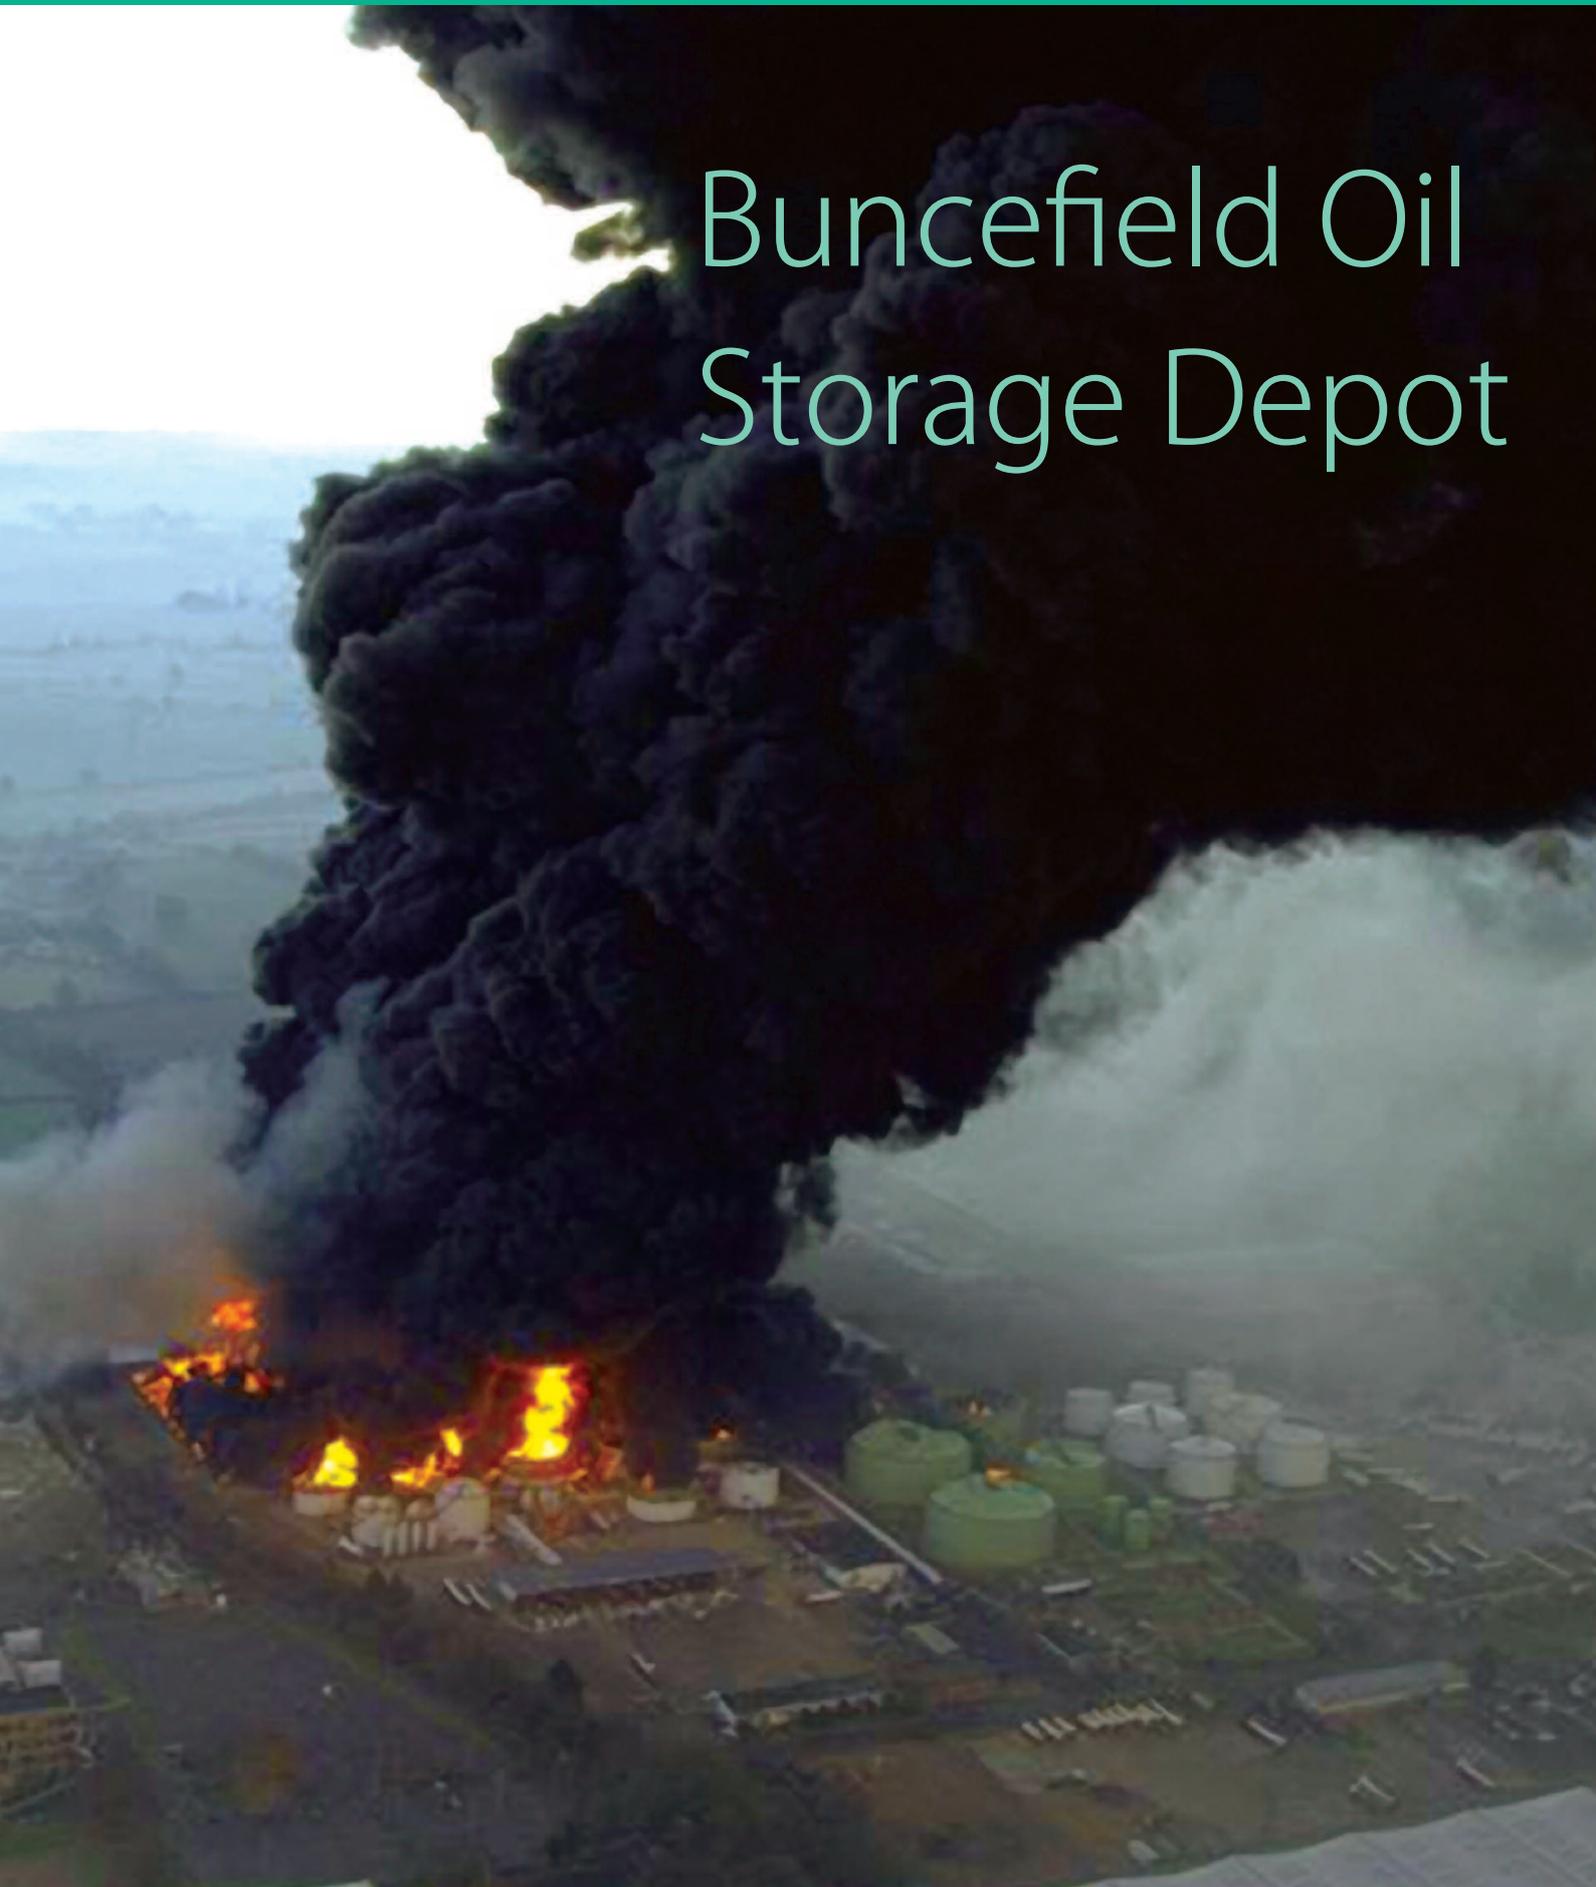
An aerial photograph of the Buncefield Oil Storage Depot. A large fire is burning in the foreground, with bright orange and yellow flames. A massive, dark black plume of smoke rises from the fire, filling the upper half of the image. In the background, several large white and green oil storage tanks are visible. The surrounding area appears to be a flat, open landscape.
